APPENDIX C. VISUAL INSPECTION PHOTOGRAPHS

C1. Photograph Station Information

C2. Year 7 (2019) Photographs

C3. Comparison Photographs

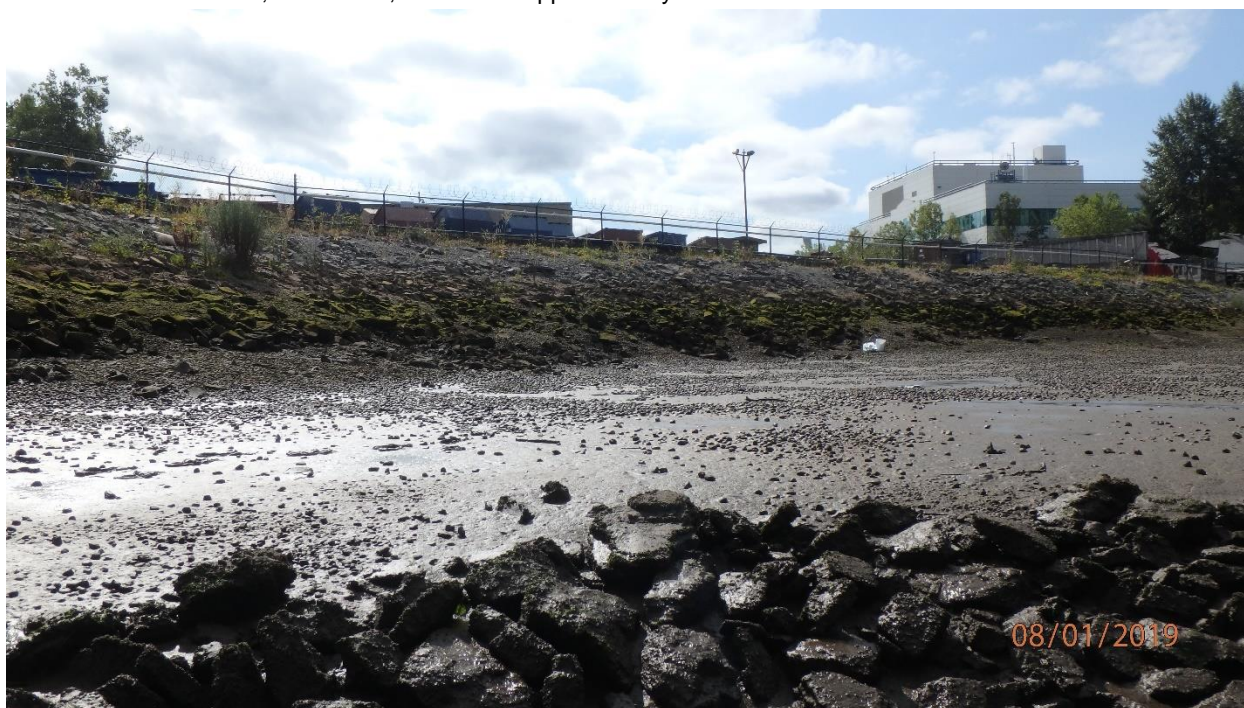
Photo G3.3. Vantage from photo station G looking southeast as part of 360° view of the entire Slip 4 EAA (3 of 6); Azimuth 0—360° M; 10:18 PDT, water level approximately -1.24 ft MLLW

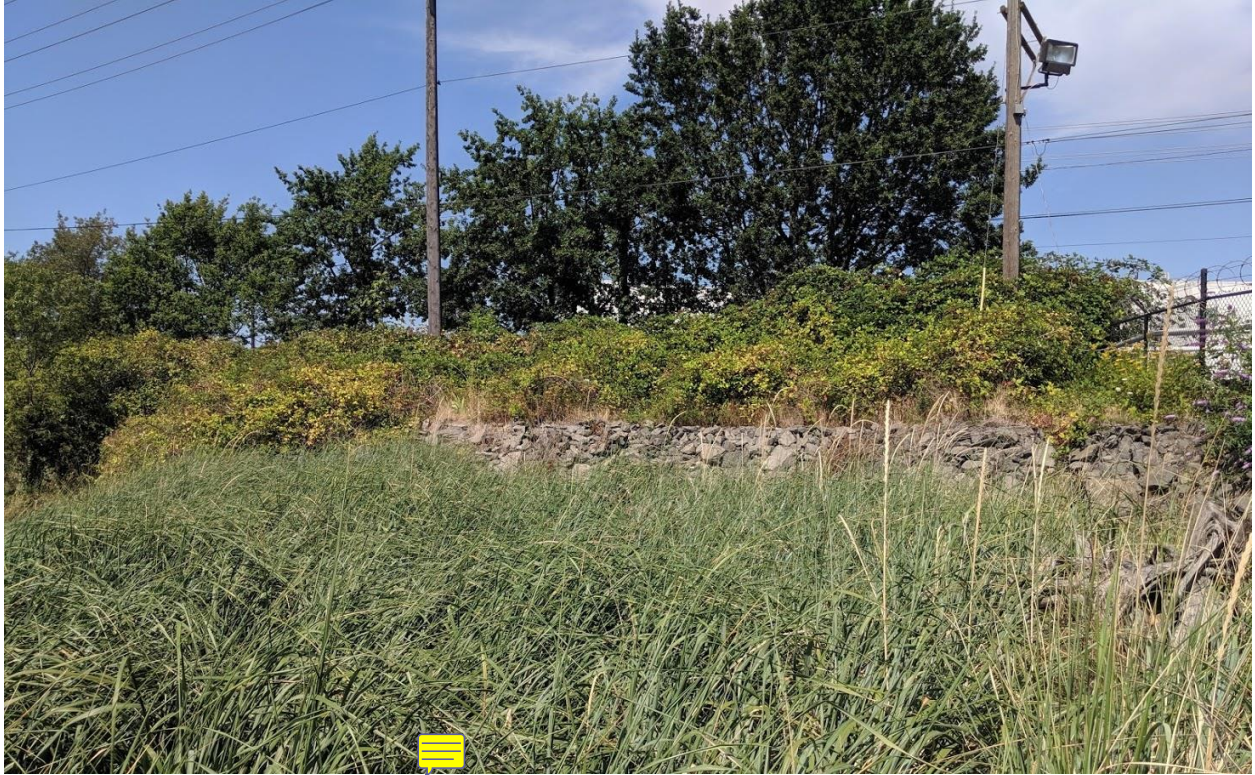
Additional photograph: northeast beach; Azimuth 12 ° M; 14:36 PDT on 8/5/2019
